论文题目：甘肃积石山 Ms6.2 地震地质灾害发育特征及孕灾环境分析

甘肃积石山 $M_s6.2$ 地震地质灾害发育特征及孕灾环境分析¹

Characteristics of geological hazard development and disaster-inducing environment of the $M_s6.2$ earthquake in Jishishan, Gansu Province

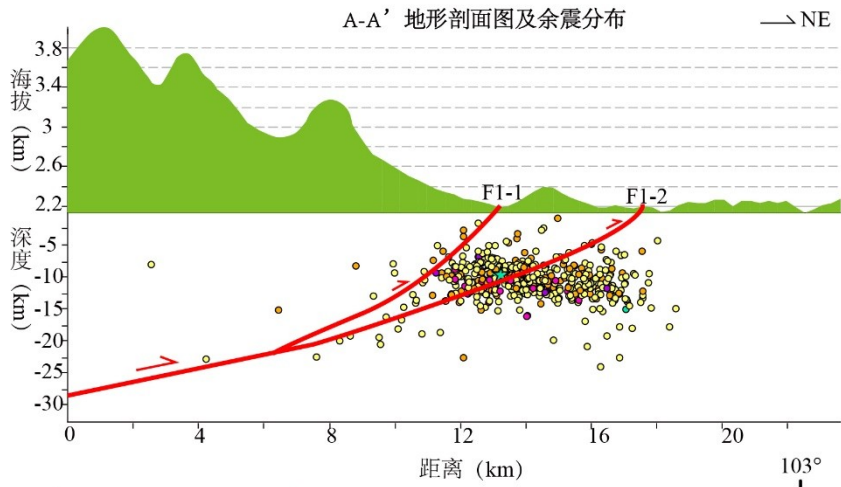
图3 区域地震地质构造图 (据陆诗铭等, 2024 修改)

★ 2023年12月18日甘肃积石山6.2级地震
 F1: 拉脊山北缘断裂带 F2: 拉脊山南缘断裂带 F1-1: 拉脊山北缘断裂带西支
 F1-2: 拉脊山北缘断裂带东支 F1-3: 拉脊山北缘断裂带东支反向断层

其中地震烈度数据源自应急管理部中国地震局 (<https://www.mem.gov.cn/>)；余震数据源自房立华, 2024；断层活动强度数据源自吴中海等, 2018

Fig. 3 Regional seismic geological map (modified after Lu et al.,2024)

研究区内主要断裂带为拉脊山断裂带，是一条全新世左旋逆冲断裂带，由拉脊山南缘断裂和拉脊山北缘断裂共同组成一组向 NE 方向凸出的弧形构造带(袁道阳等, 2005)，地貌上有较明显的陡坎等新活动特征，分割了临夏盆地与左侧高山区。该断裂在(3136±51)a. BP 左右发生过古地震事件，估算断层全新世中晚期以来的滑动速率为 0.51mm/a(李智敏等, 2014)。依据小震密集分布研究，认为拉脊山断裂作为日月山走滑断裂带与西秦岭断裂带的构造转换区，具备发生中强地震的构造条件，而断裂带两侧盆地内部不存在规模较大的断裂，危险性较低(图 3)。

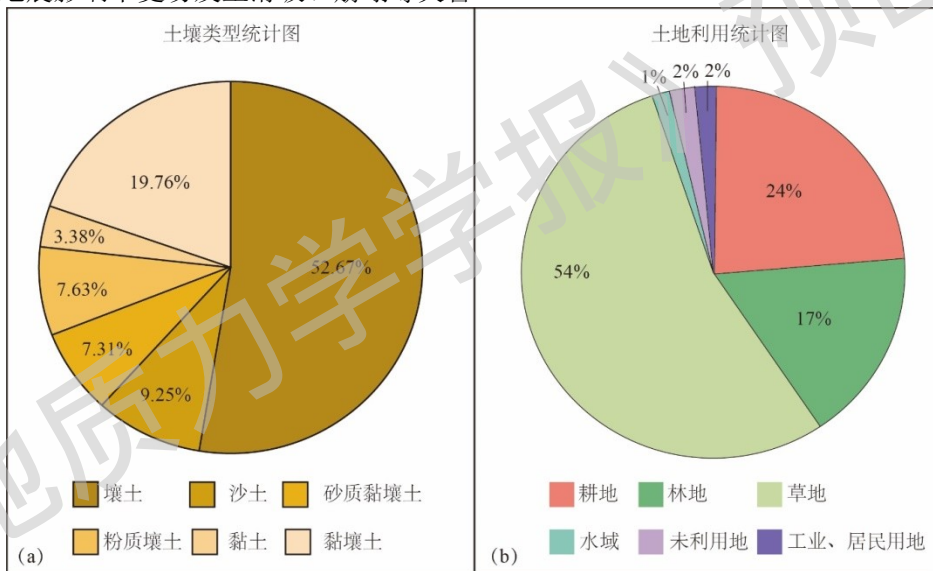
图4 土壤类型分布图及土地利用分布图

Fig. 4 Maps of soil types and land use distribution

根据区域土壤质地分析 (采用 FAO90 土壤分类, 数据来源于国家青藏高原数据中心), 研究区以壤土为主, 约占 52.67%; 其次为黏土, 占 19.76%。壤土具有适中的含沙量, 表现出良好的保水性和排水性; 黏土质地较黏重, 含沙量少, 保水能力强但排水性差; 沙土因颗粒较大, 结构松散通透, 保水能力弱, 常见于干燥环境中 (图 4a)。积石山县附近富含黏土, 水分含量高, 地震后容易引发砂土液化、泥石流等地质次生灾害。

根据区域植被覆盖率分析 (数据来源于中国科学院地理科学与资源研究所 <http://www.resdc.cn>), 研究区内多为草地和林地 (图 4b), 分别占 54%和 17%, 林地的存在有助于固土, 减少地表径流, 增强土壤稳定性, 从而降低泥石流和滑坡等自然灾害的发生风险。而在植被覆盖率较低的区域, 土质易沙化, 土壤稳定性差, 土地裸露度高, 在地震影响下更易发生滑坡、崩塌等灾害。

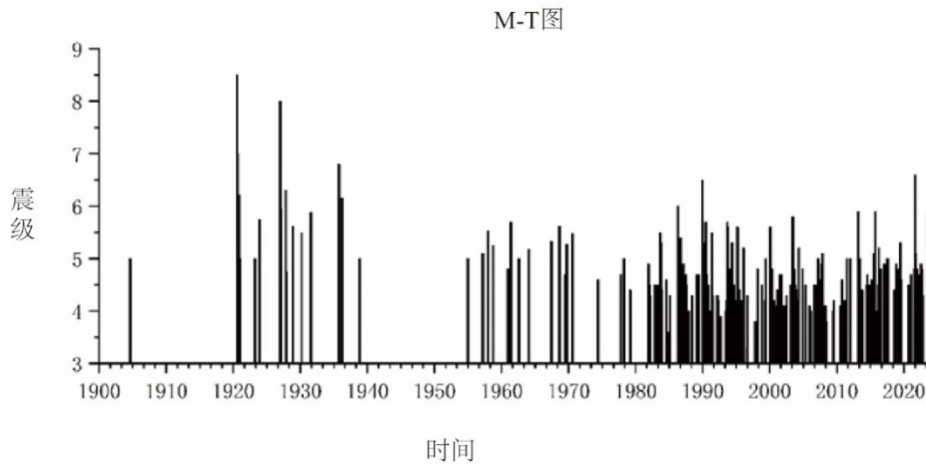
图 5 中—强震 $M-T$ 图

Fig. 5 M-T diagram for moderate to strong earthquakes

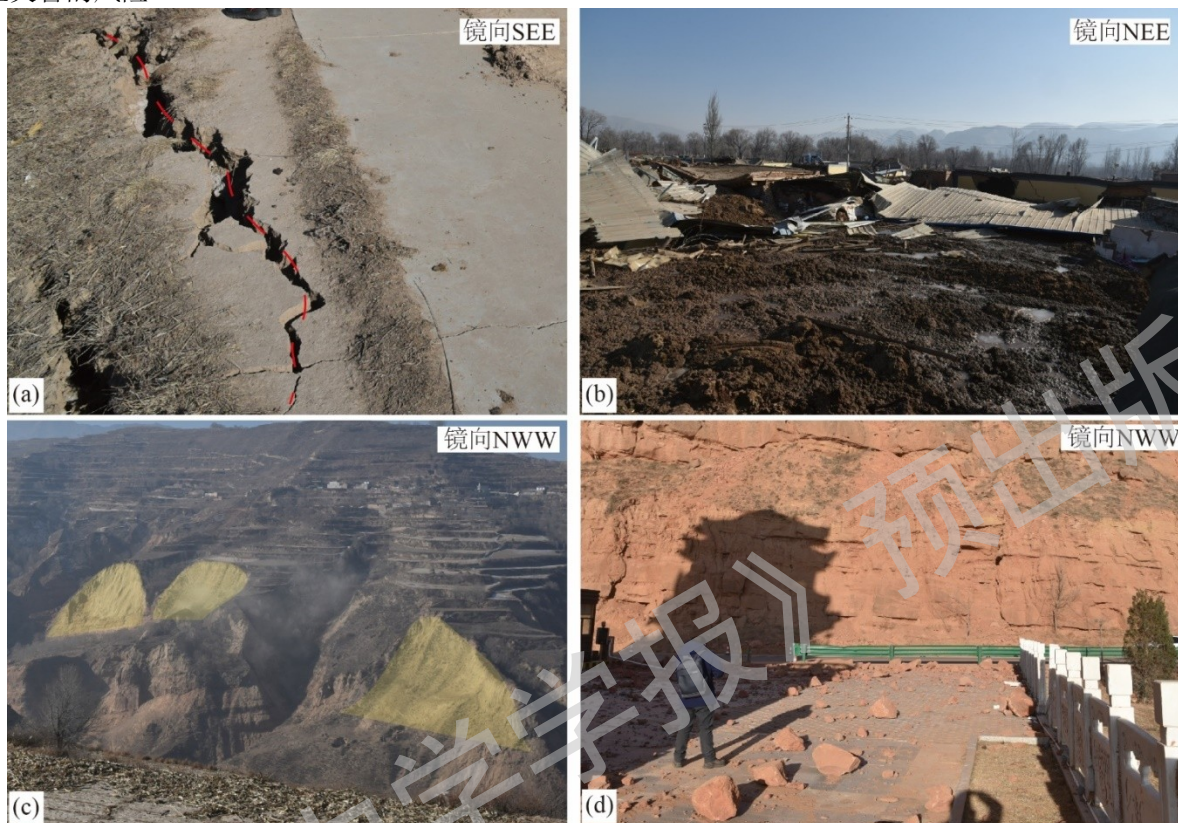
图6 地质次生灾害点野外调查图

a—积石山县东南侧边坡旁地裂缝；b—中川乡东南侧泥流；c—积石山县东南侧滑坡群；d—大河家镇北侧见崩塌落石

(a) ground cracks in the southeastern of Jishishan County;(b) mudflows in the southeastern of Zhongchuan Township; (c) landslides in the southeastern of Jishishan County;(d)avalanches in the north of Dajiahe Town;

区域内崩塌和滑坡的集中分布与山麓堆积物、厚层第四系黄土发育、坡度较大及缺乏植被固土等因素密切相关,尤其是在地震作用下,这些条件易产生蠕滑-拉裂破坏(郭圣煜等,2024;郭富赞等,2024;强德霞等,2022)。部分远离震中的区域,如临夏盆地和河流附近的滑坡和崩塌,多为先存的灾害点在地震动影响下重新激活,加剧了灾害。泥石流主要发生在拉脊山前的斗状河谷,其发生受区域地形地貌及水文条件控制,松散黄土在水流冲刷下不断重新堆积,提供了丰富的泥石流物源,从而在地震后爆发,表现出规模大、流速快、破坏性强的特点(强德霞等,2022)。总体来看,地震次生灾害的类型及其分布反映了地质环境条件的影响,地层岩性、地形坡度及水文条件等共同决定了地质次生灾害的易发性和分布特征。
